W/O. No.: AME512-08-19-59085-1
P.O. No.: Ck 1711
Report Date: 8/21/2009

Description: Walkboard Planks
Material: Perforated Steel

Identification: 120" x 9"
Description: Walkboard Planks
Material: Perforated Steel

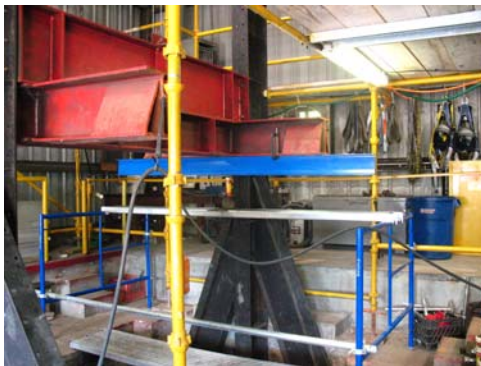
Point load setup

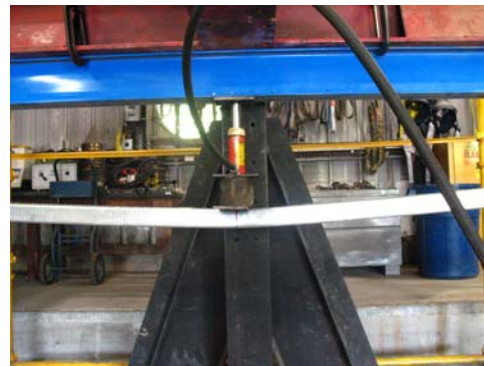
Point load failure at 1,100 lbs

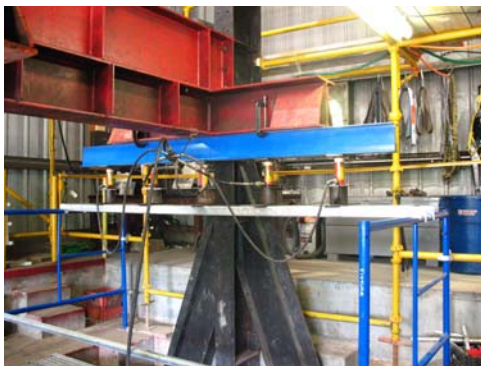
UDL setup

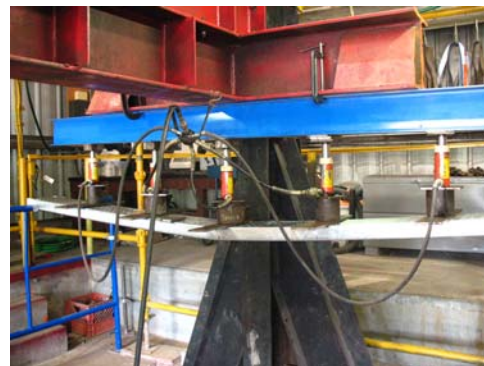
UDL failure at 1,535 lbs

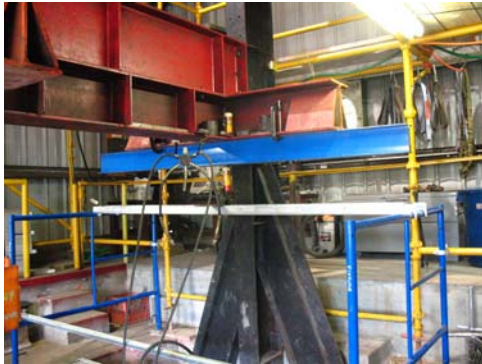
Point load setup

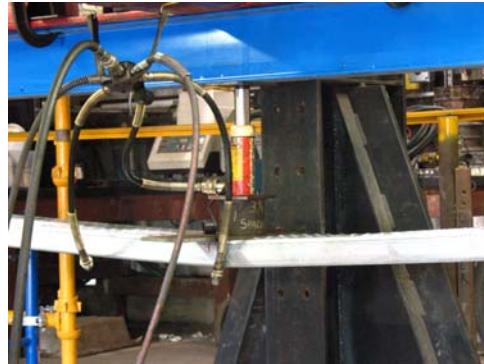
Point load failure at 1,475 lbs.

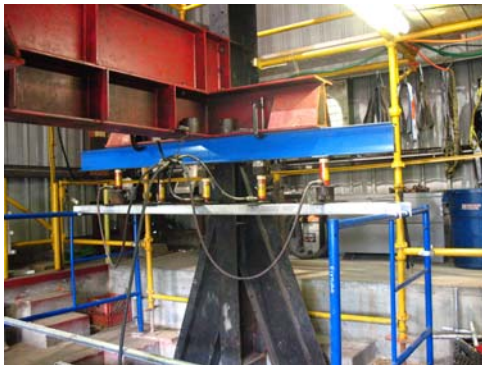
UDL setup

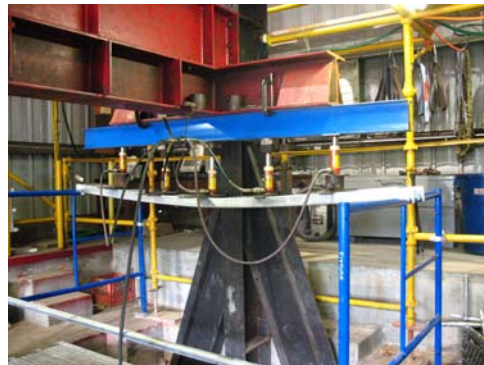
UDL failure at 2,330 lbs.

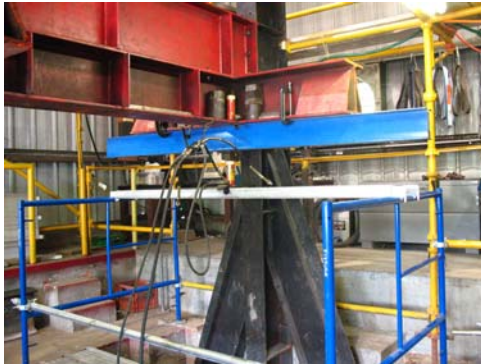
Point load setup

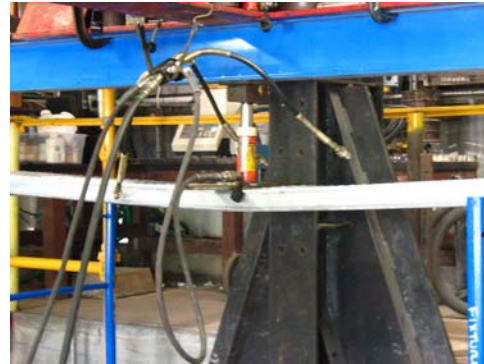
Point load failure at 1,525 bs.

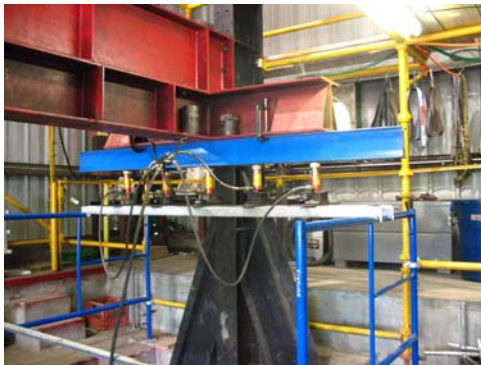
UDL setup

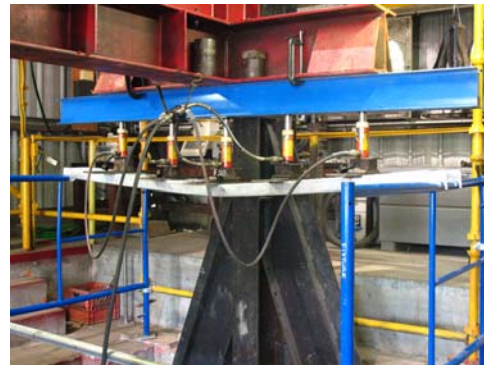
UDL failure at 2,330 lbs.

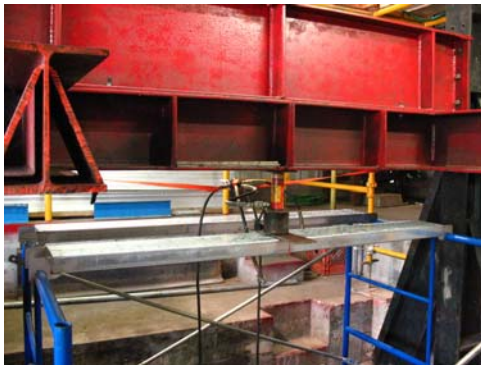
Point load setup

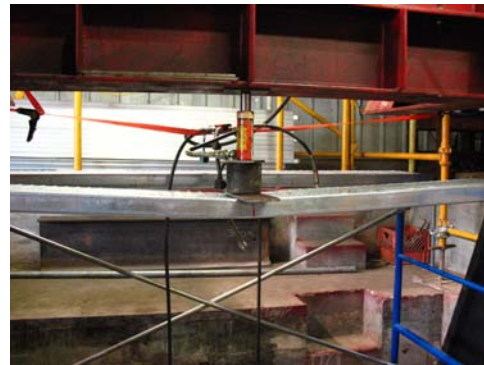
Point load failure at 1,850 lbs.

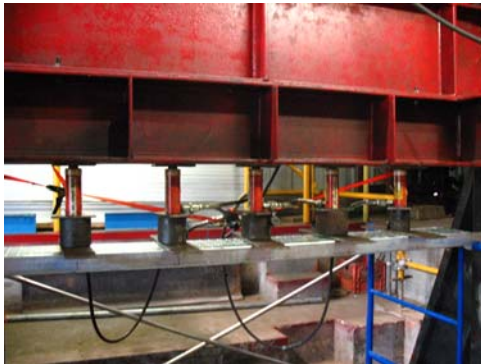
UDL setup

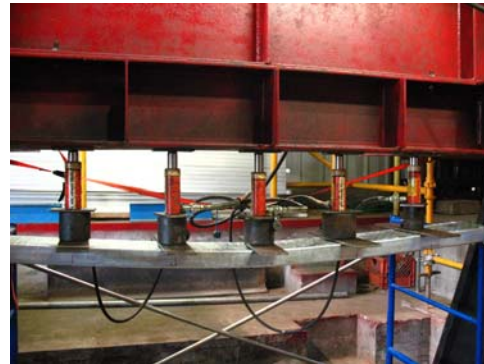
UDL failure at 3,030 lbs.

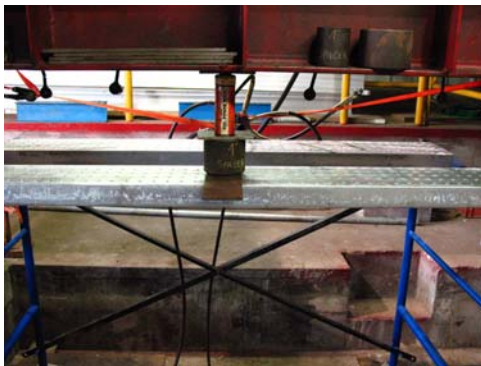
Point load setup

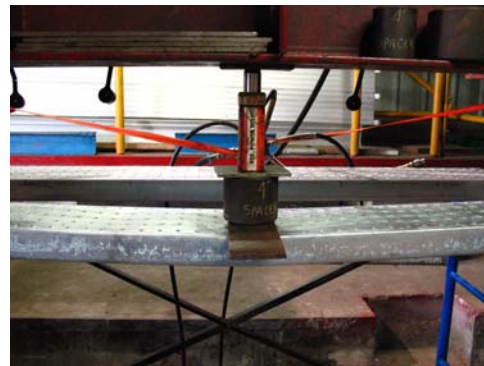
Point load failure at 2,275 lbs.

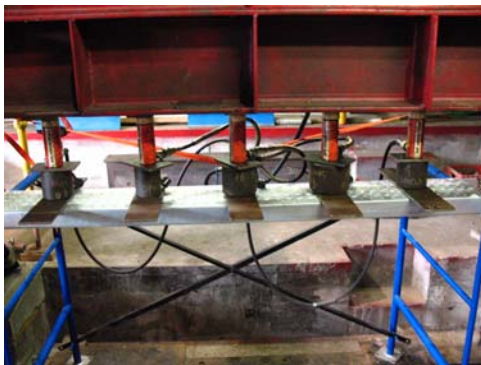
UDL setup

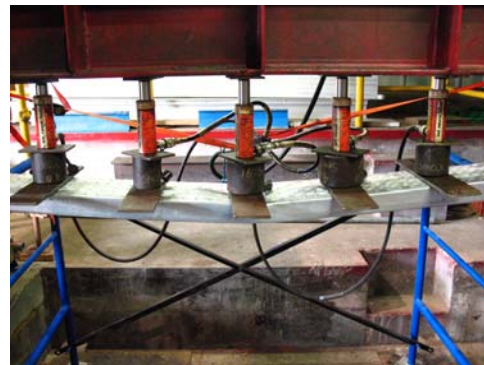
UDL failure at 3,685 lbs.

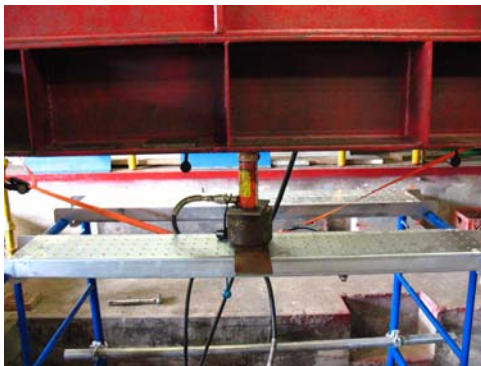
Point load setup

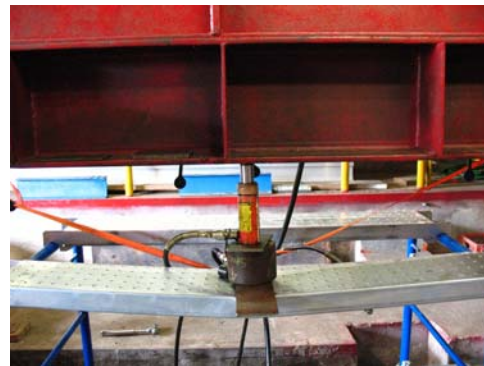
Point load failure at 2,790 lbs.

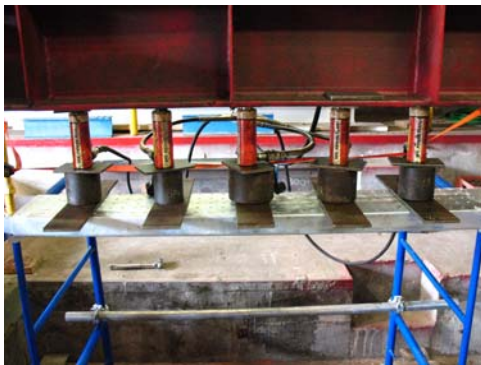
UDL setup

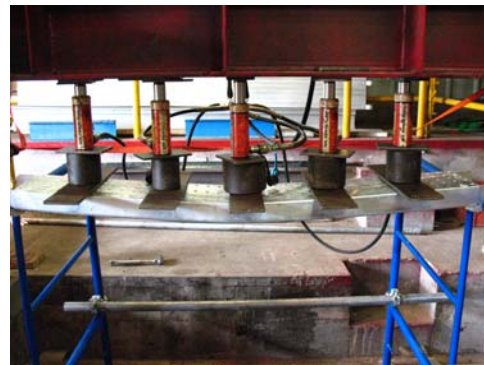
UDL failure at 4,545 lbs.

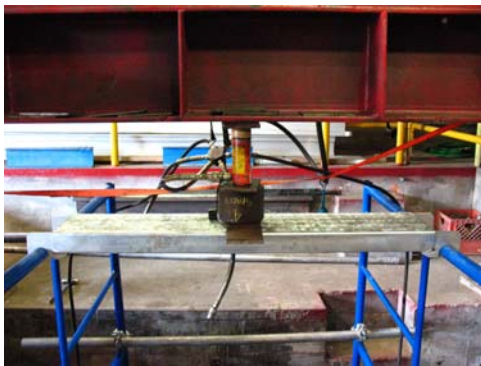
Point load setup

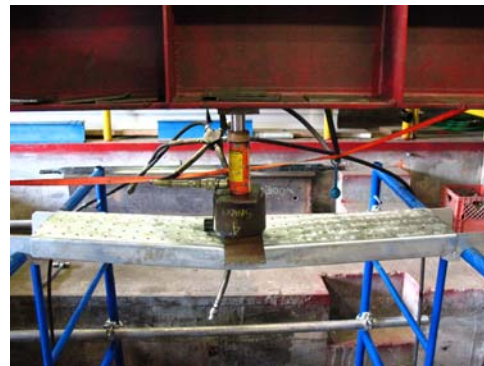
Point load failure at 3,415 lbs.

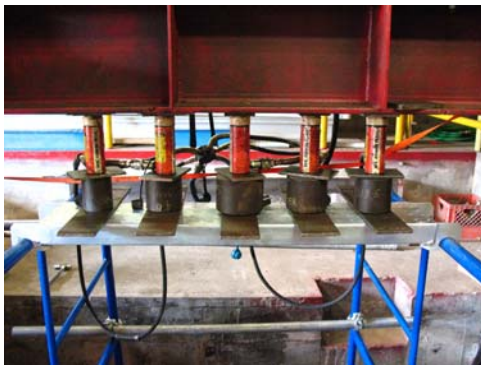
UDL setup

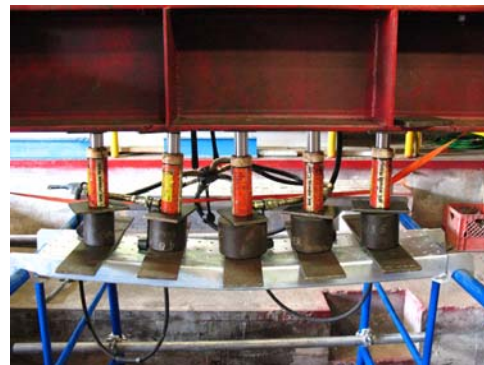
UDL failure at 6,315 lbs.

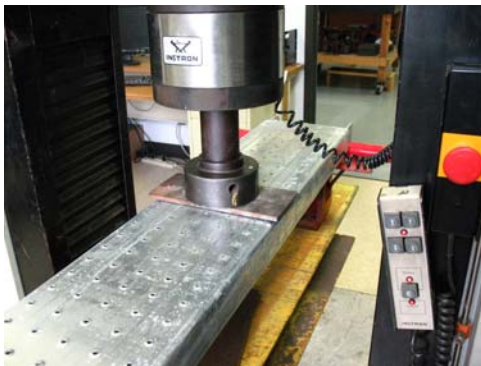
Point load setup

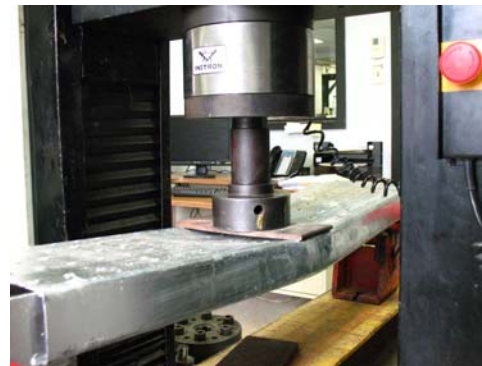
Point load failure at 3,900 lbs.

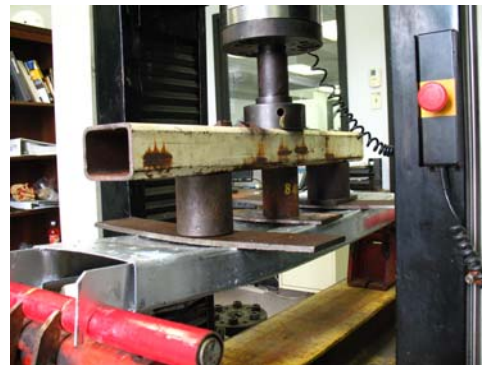
UDL failure at 6,715 lbs.

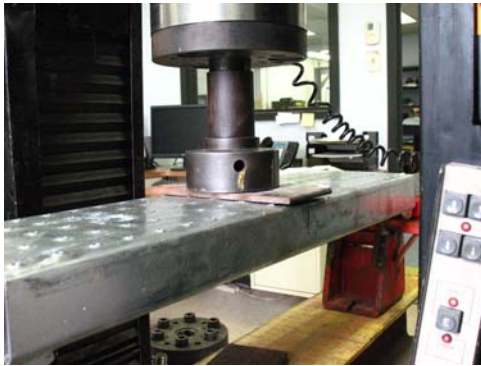
Point load setup

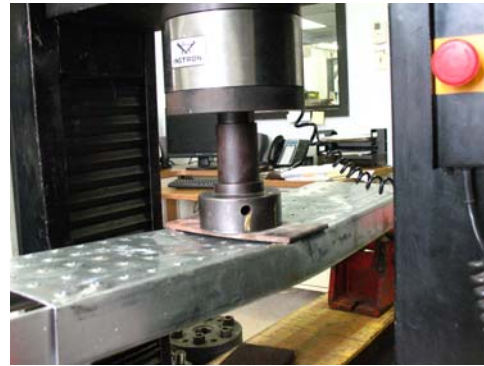
Point load failure at 4,435 lbs.

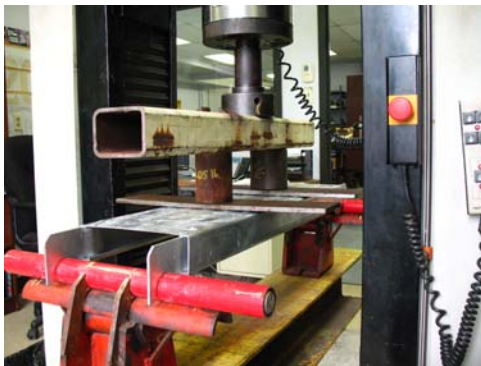
UDL setup

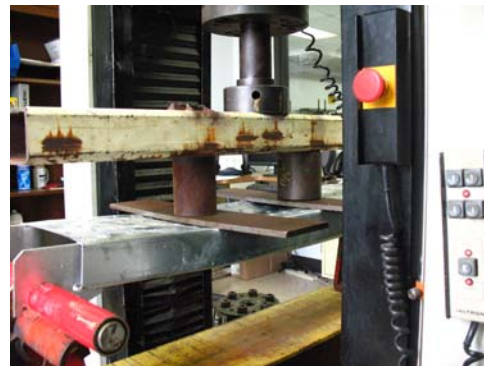
UDL failure at 7,060 lbs.

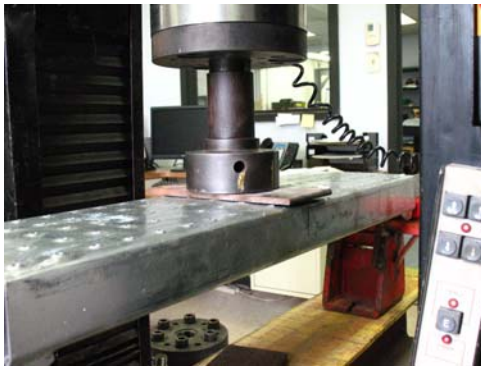
Point load setup

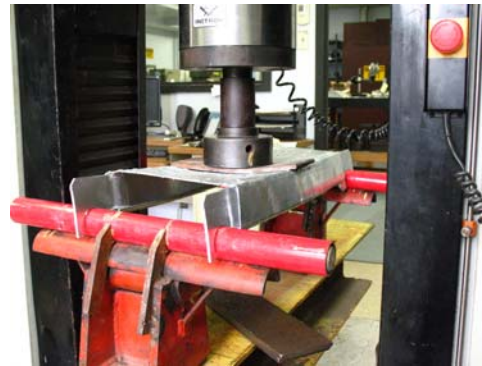
Point load failure at 5,715 lbs.

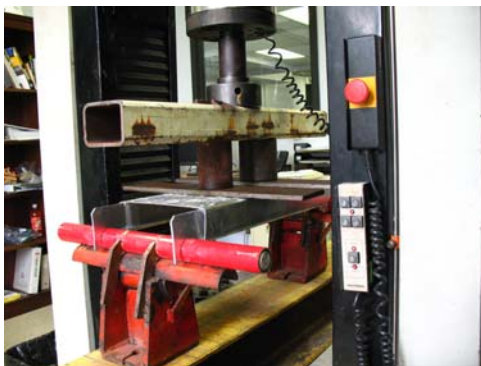
UDL setup

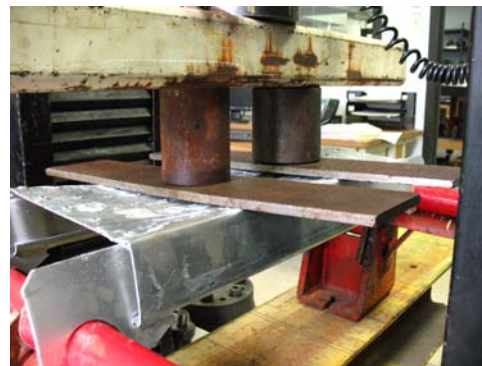
UDL failure at 7,970 lbs.
